Report on the Quinquennial Survey

TAUNTON St George

Report on the Quinquennial Survey for 2022

Survey by Jonathan Saunders RIBA AABC

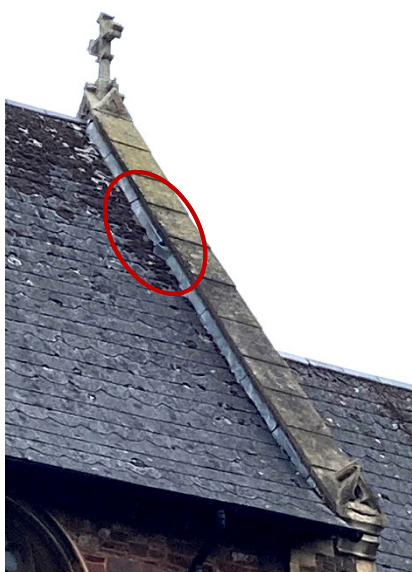
- 5.1 The church is in generally very fine condition, which is a testament to its structural quality as well as ongoing care by the people.
- 5.2 Pitched roofs, those that are visible, are sound and I could not see even a single slipped 'slate'. I noted just one defect; the flashing at the east end of the nave south slope.

Fig 1
Displaced flashing at the east end of
the nave south slope.

25.	Items for Immediate Attention	Ref.	£
25.1	Repair flashings at the east end of the nave south slope.	7.2	1a
25.2	Investigate displacement of coping at east end of south aisle and re-bed or repoint as necessary.	7.4	1a

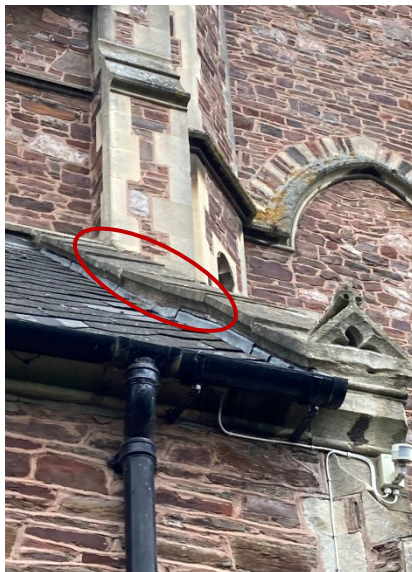
- 7.2 Lead flashings at abutments with parapets and at the top of aisle roofs are all sound as far as I could judge, other than two areas of concern.
- A section of flashing at the east end of the nave south slope abutment with the chancel arch has fallen away and there is an open joint above the flashing to the aisle roof immediately below.

Fig 2
Displaced flashing at the west end
of the north aisle.

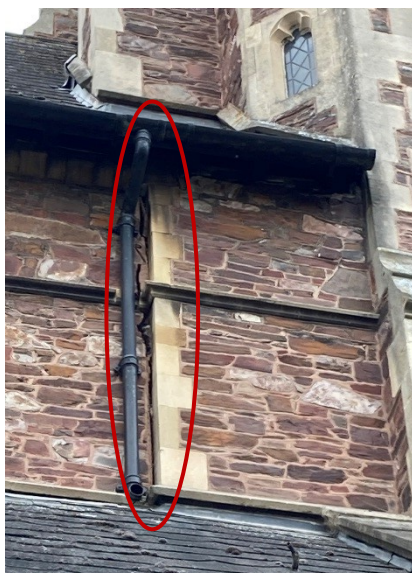
- There is quite a wide crack at the east end of the north clerestory abutting the tower. This is longstanding and appears to have gone un-noticed. Deep pack-pointing is required for weathering and to serve as a tell-tale.

Fig 3
Cracking between the north
clerestory and the tower. This is
long-standing but should be
pack-pointed.

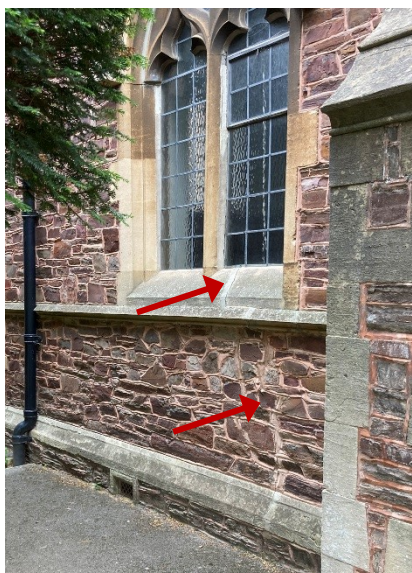
- 8.4 There are two areas of movement manifesting on the exterior – others are described under the interior:
- In the west window the south aisle. Here, there is significant historic structural movement up to, perhaps, 50mm which has been repointed in cement mortar and since then, perhaps, towards the end of the last century there has been a further 5mm of movement, though I cannot be certain of this timing.
This movement manifests itself in cracks in the cill, extending through the rubble below and also in the arch above. This movement leads me to recommend that baseline monitoring is at least considered by a structural engineer, and is part of

my recommendations. The same movement has caused a smaller crack above the south door.

Fig 4
The window adjacent to the south
porch has long-standing cement
repairs possibly 30 or 40 years old
to fill settlement cracks but
movement continues due to slight
movement of the tower.

This movement is long-standing and unlikely to be serious but baseline monitoring is recommended. The photographs are included for identification purposes of typical cracking and are not an exhaustive catalogue.

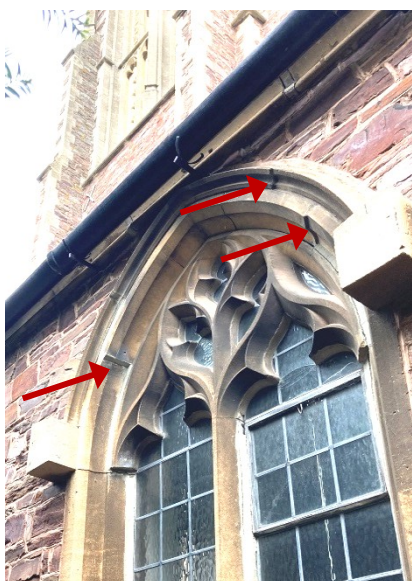
Fig 5
Upper part of the same window.

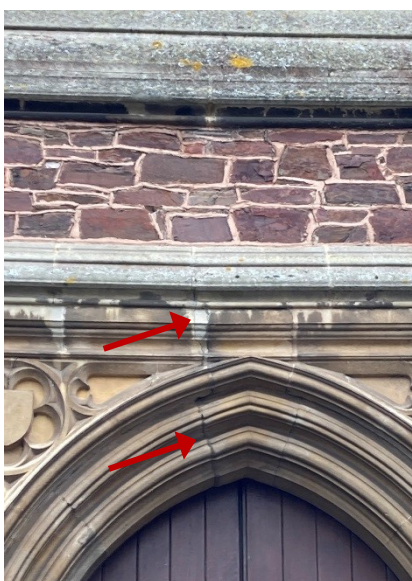
Fig 6
Lesser, but also long-standing
cracking above the south door has
the same cause.

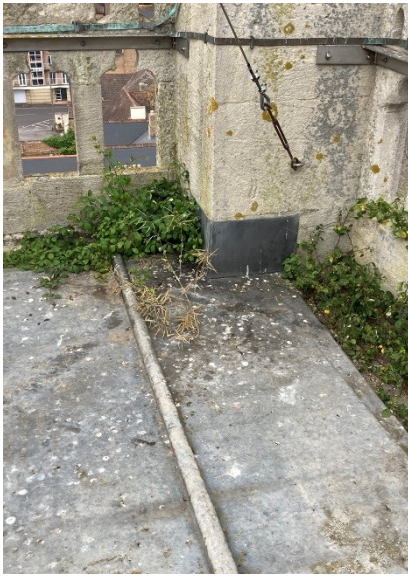
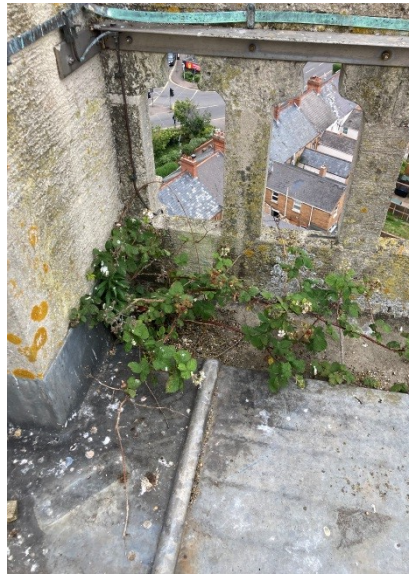
Figs 7 and 8

- 10.9 There is extensive vegetation in these channels, particularly the south-west corner and this should be cleared as soon as practical; there is at present a pair of unfledged gulls and, at the time of my inspection, a very anxious mother overhead.

Extensive vegetation in tower parapet gutters need to be cleared and any open joints repointed. If it appears that roots are established it would be wise to pre-kill before removal.

25.3	Repair the broken quarry in the south aisle westernmost window.	9.5	1a
25.4	Clear vegetation from lower roof parapet gutters from tower roof gutters and repoint open joints in the stone channels.	10.7, 10.8	1a

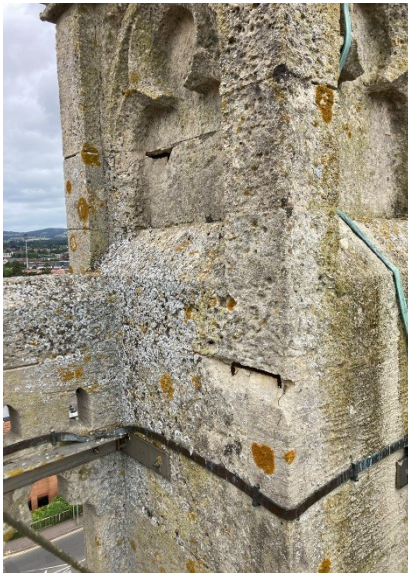
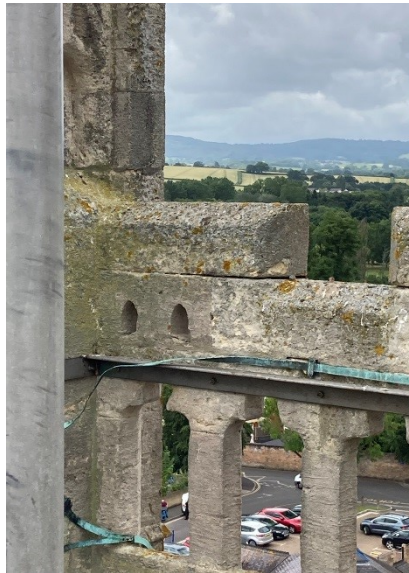
Figs 9 and 10

- 10.10 The parapet, including the corner turrets, appears to be structurally sound though suffering from expansion of rusted cramps, which has caused some spalling and lifting of copings. This is a very difficult defect to address because there will be multiple cramps embedded in the structure and the only sure way is completely dismantling. However, at the present time this is not causing structural instability and I recommend that the open joints, on the inside face, are pointed-in in lime mortar to give a small measure of projection and increase the life of the span. Rust treatment would be appropriate to the exposed face of any ironwork, though this is by definition fairly limited treatment.

There is evidence of quite extensive damage and jacking from rusting iron cramps. There will almost certainly be further instances on the outside face of turrets and parapets. This is not unusual in work of this period but remedy is both difficult and costly, particularly at this height.

26.2	Repoint areas of stone pointing to the tower parapet after treatment of the exposed ironwork with rust preventative.	10.9	1b
26.3	Monitor the condition of bird mesh in the bell chamber and replace when necessary with stainless steel mesh, ideally powder coated.	10.13	1b

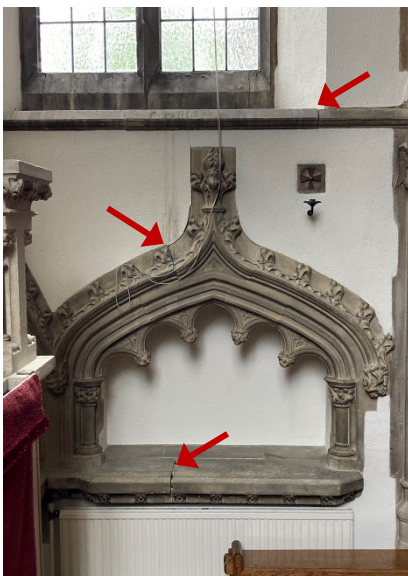
Fig 11

Long-standing structural movement in the chancel south wall niche.

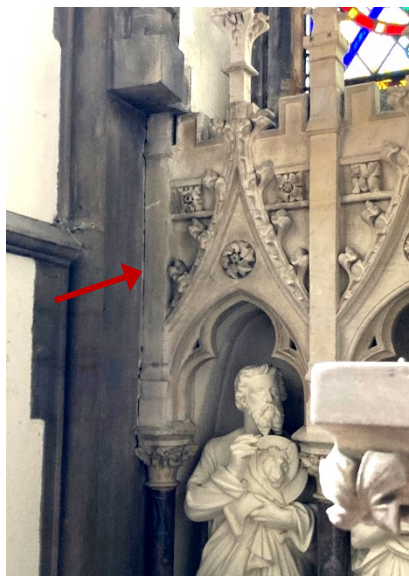
Fig 12

Ditto at the north end of the chancel reredos.

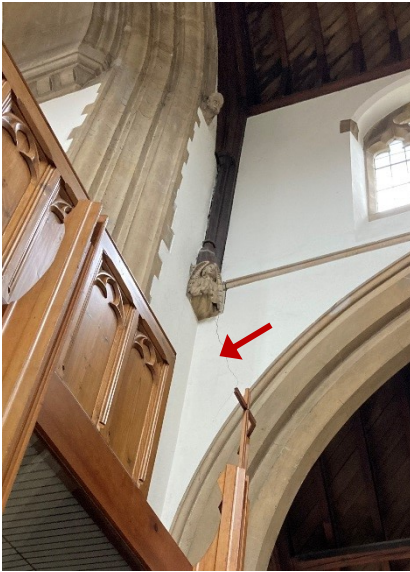
Fig 13
Structural cracking at the west end
of the north clerestorey. See also
Fig 3.

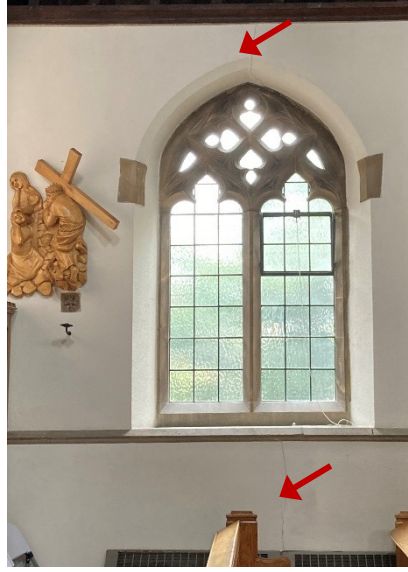
Fig 14
Similar cracking around the west
end window of the north aisle.

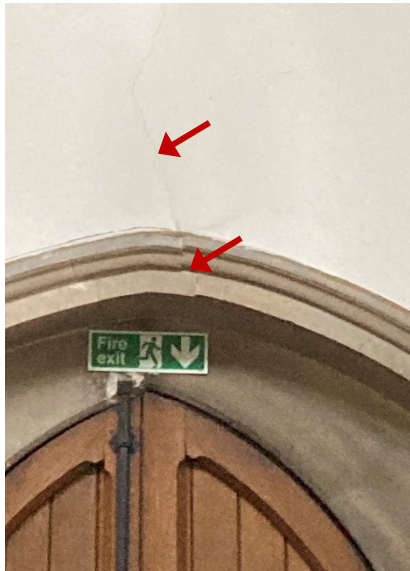
Fig 15
Movement above the south door.

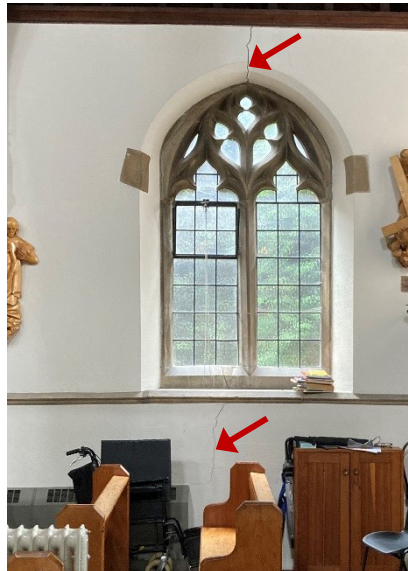
Fig 16
Similar movement around the south
aisle window as the south aisle. See
also Fig 4.
