TAUNTON St George's Rectory

Report on the Quinquennial Survey

TAUNTON St George Rectory

Report on the Quinquennial Survey for 2022

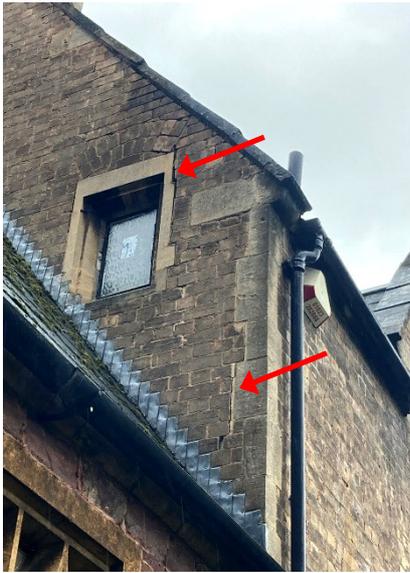
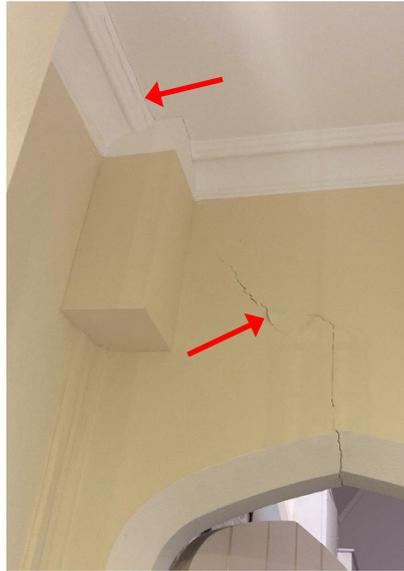
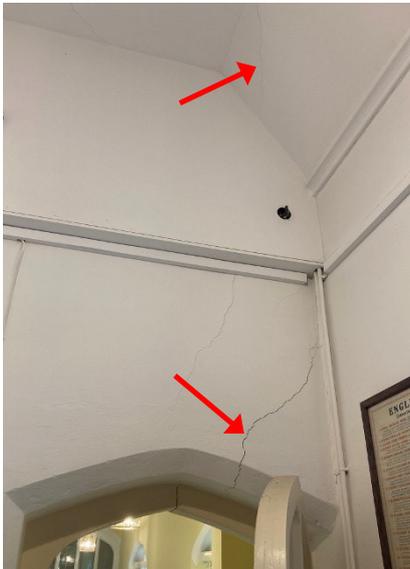
Figs 1, 2 and 3

- 9.3 There is long-standing movement in the east gable extending down from the bathroom window. This has been filled more than once and is continuing as recently manifested in cracking over the sacristy passage doorway.

- 9.4 The internal cracking manifested quite suddenly in recent weeks through recent redecorations. This cracking is very clean with no obvious evidence of multiple filling as might be expected unless this was done to exceptionally high standard. There is no recollection that cracking pre-dated the redecoration but in any event the associated cracking externally is long-standing.

- 9.5 The cause of movement is not clear. There are some below ground drains in the vicinity which may be the source of foundation movement. As the extent of cracking is more than might be expected from, say, seasonal movement so I recommend that a structural engineer is consulted.

13.3 Shortly after my inspection significant cracking increased in the arch over the sacristy door that was not evident on my first visit.

13.4 Cracking is in the vicinity of long-standing crack in the east gable but it is a mystery why the internal cracking is clean with no sign of previous making good.

Cracking in the east gable is long-standing and extends to the interior above the doorway to the sacristy as 2 and 3 following.

13.5 Because the movement is so sudden I recommend that a structural engineer advises on remedial action.

I cannot account for this movement and recommend that a structural engineer is appointed to assess this.

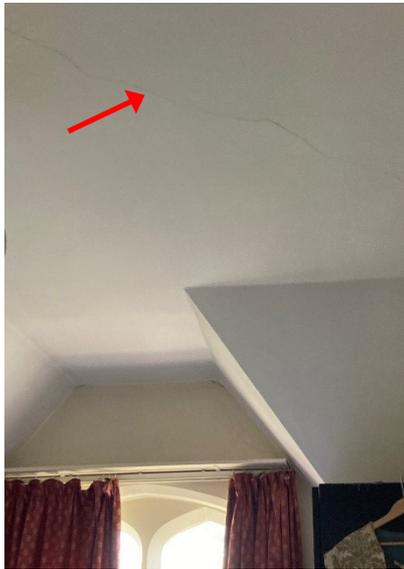
Fig 4

13.2 .There is superficial cracking in the north bedroom and in the ground floor room opposite the kitchen. This appears to be simply the result of age rather than anything sinister but this should be reviewed in if cracking increases.

Minor cracking grinning through the newly decorated ceiling is 'normal' movement in a new building and does not, as it stands, indicate an underlying weakness in plaster bond but should be investigated further if it develops noticeably.

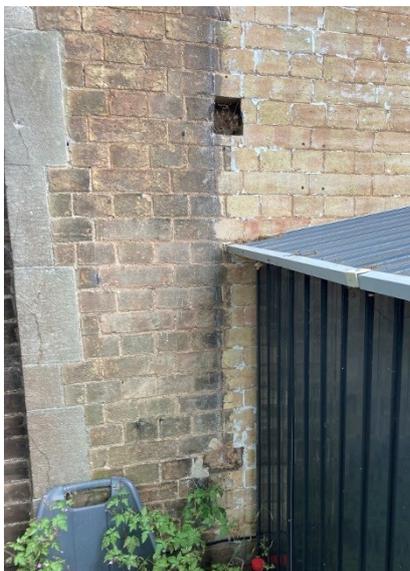
Fig 5

- 9.6 A modern greenhouse built on the site of an early structure has been demolished in recent years. Pockets left in brickwork should be built up.
- 9.7 There is a small area of filed pointing in the east wall of the utility room which should be made good when other pointing is in progress

The pocket from the demolished glass house should be built up in matching brick.

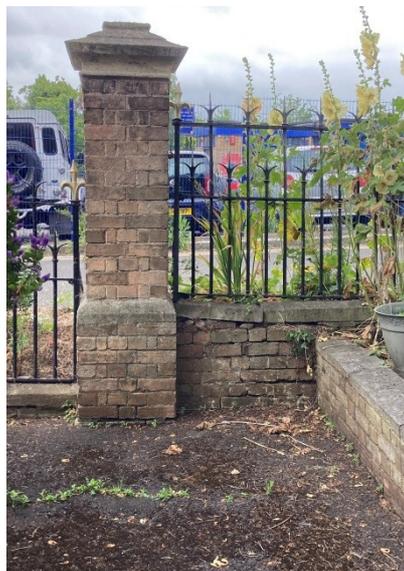
Fig 6

Boundary railings. The infill course of bricks below the coping show movement is long-standing.

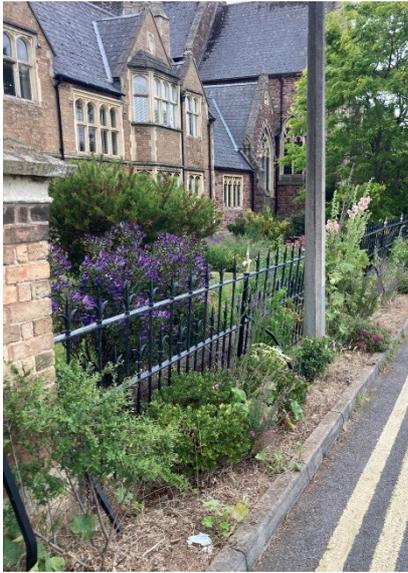
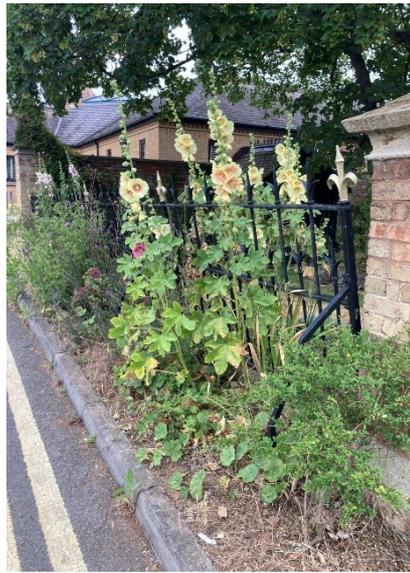
Figs 7 and 8

12.2 The wall has settled outwards and there is some rusting in railings and failure of stone copings. This is entirely repairable though probably requiring reconstruction on new foundations.

Outward rotation of the railings suggest that foundations have failed.

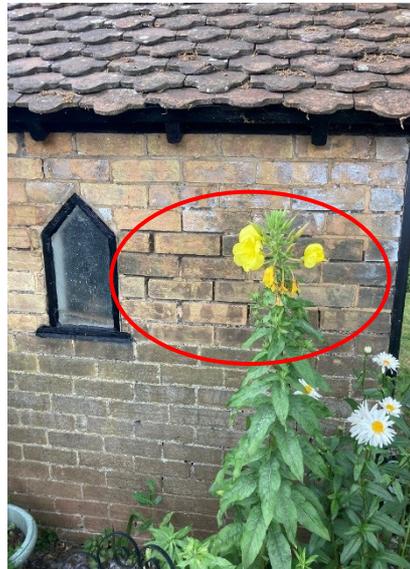
Fig 10

12.5 There is a small summer house against this wall in brickwork under profiled clay tiles. I did not inspect the interior but I could see no structural defects though a small area of brickwork of the south wall needs repointing.

A small area of failed pointing in the north wall of the summerhouse could be repointed when other works are underway, such as the boundary railings, but this is by no means urgent.

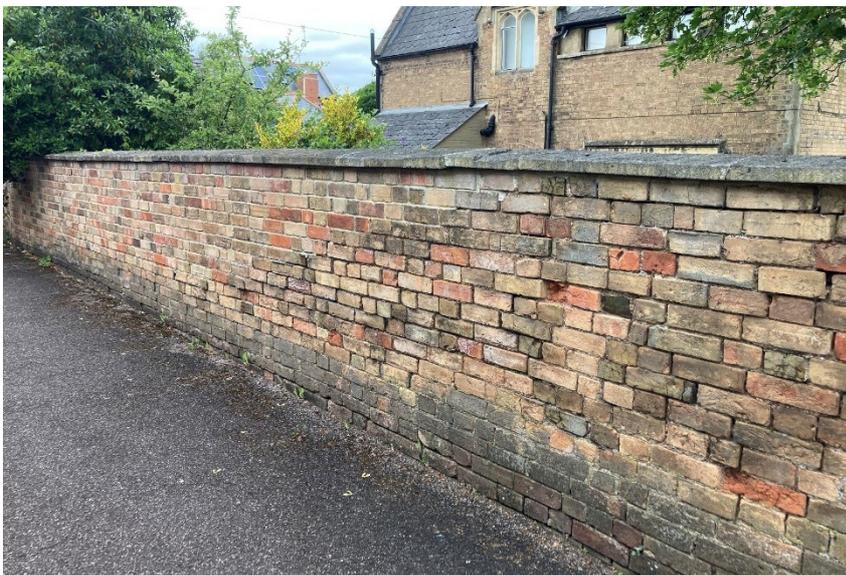
Fig 11

12.4 The south boundary which is a retaining wall to the parish centre path is structurally sound but deserves some repointing in the medium term.

The east boundary wall adjacent to the Parish Centre path deserves repointing within the quinquennium and might sensibly be included with repairs to the boundary railings.
