## TAUNTON St Teresa of Lisieux

### Report on the Quinquennial Survey

## Report on the Quinquennial Survey for 2022

Survey by Jonathan Saunders RIBA AABC

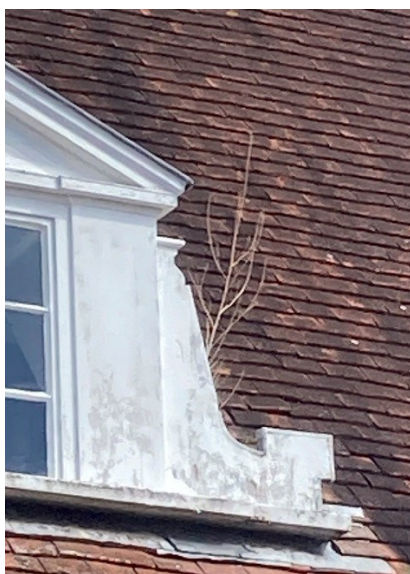
- 7.3 I noted woody growth growing from the back gutter of one of the south dormer cheeks, with further growth, currently dried out against the east wall of the tower.

Fig 1  
Woody growth in the back gutter to the south dormer.

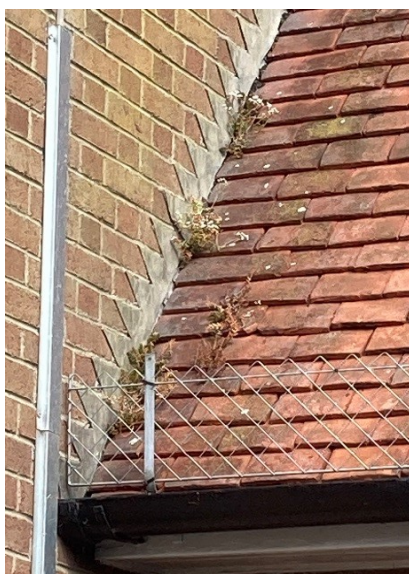
Fig 2  
Dried vegetation due to the very hot summer indicates accumulation of humus.

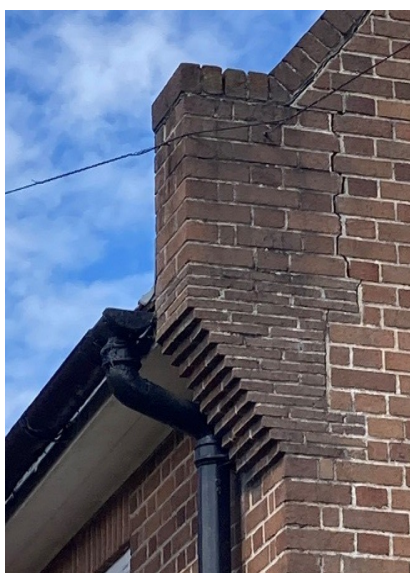
8.4 The brickwork at the bottom of the east gable south slope has moved outward, with resultant cracking behind the corbelled work and lifting of the copings. Kneelers can be a point of weakness because of the weight of the copings over the whole length of the gable, but it is surprising that this is only occurring in one of the four such locations kneelers.

Fig 3  
The south east kneeler to the chancel is moving slightly outwards. This is not yet urgent but some 'pinning' is desirable to ensure that the issue does not get worse.

This movement is not new and it would be interesting to know from earlier reports, had they been available, how long this has been evident. Remedial work at this stage would probably involve dowelling with stainless steel dowels to secure the kneeler rather than rebuilding, and I think this should be planned for within the next couple of years.

| 25. | Items for Immediate Attention | Ref. | £ |
|---|---|---|---|
| 26.4 | Repair the displaced kneeler at the south east corner of the chancel, method to be determined but probably by dowelling. | 8.4 | 1b |

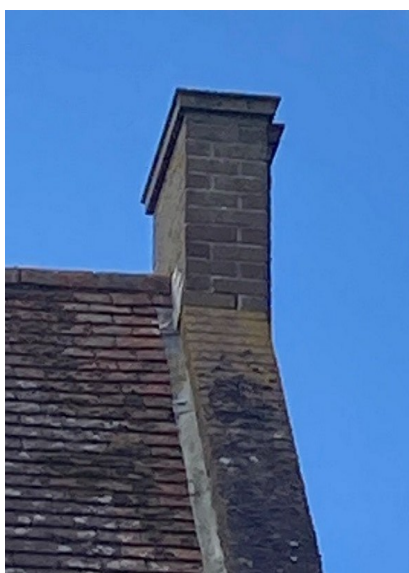
- 7.4 Copings to the east and west gables are special bricks on edge, which all appear to be generally sound though it appears from a very oblique viewpoint that there may be open joints in the south channel coping. Inspection when there is access for other purposes is recommended.

Fig 4  
Copings to the chancel parapet have some open joints and one at the base of the chimney, both sides.

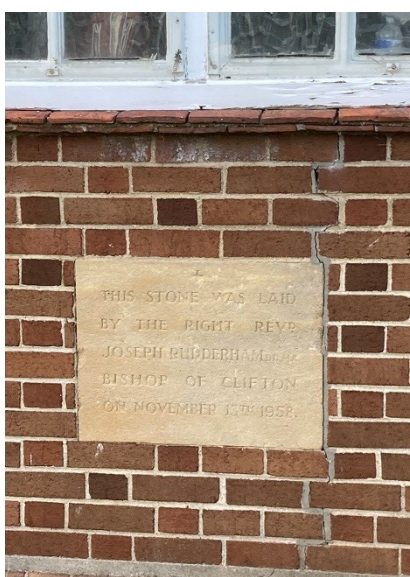
8.2 It would not be usual to see structural movement from this type of 'brittle' construction, but here I can only see a crack below the west window extending from the cill to the ground. This is clearly longstanding, probably developing soon after construction as a consequence of initial settlement, concentrated here by the weakness in the wall created by the window itself. I do not see this cracking extending above the window to the parapet.

Fig 5  
Crack below the west window is long-standing and there is no evidence if it progressing.

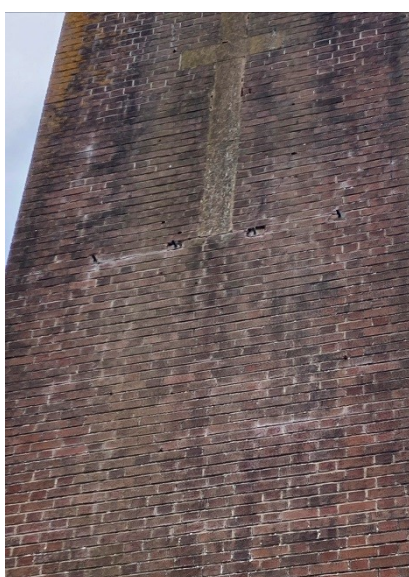
8.7 The brick walls here are clearly cavity, as evidenced by the copper weep pipes at mid-height and just above the nave eaves level, though I cannot see any strong sign of a cavity tray at these points.

Fig 6  
Weep holes, with copper drain pipes, in the tower suggest cavity construction with tray at this level. The damp in the baptistry area may well be associated with this feature.

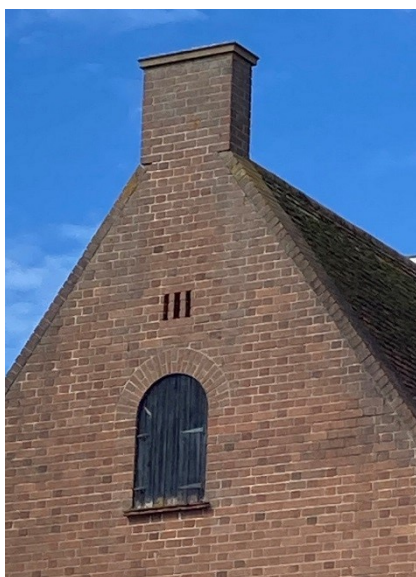
Fig 7  
The 'hatch' into the chancel roof space is in need of redecoration and, quite likely, repair.

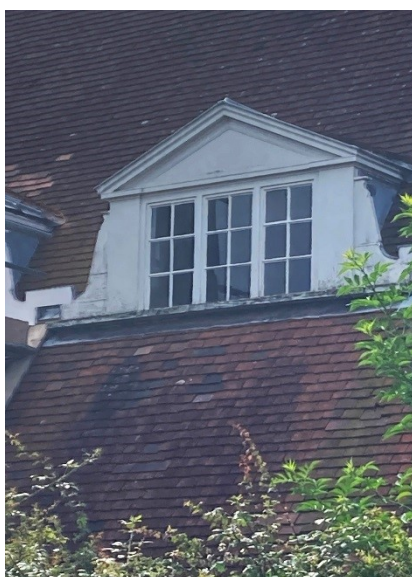
Fig 8  
One of the north dormers is showing cill in particular requiring redecoration but all should be done when access is available.

| 25. | Items for Immediate Attention | Ref. | £ |
|---|---|---|---|
| 26.5 | Commence a programme of window redecoration planned around access which might include roof repairs. | 10.2, 4 | 3 |

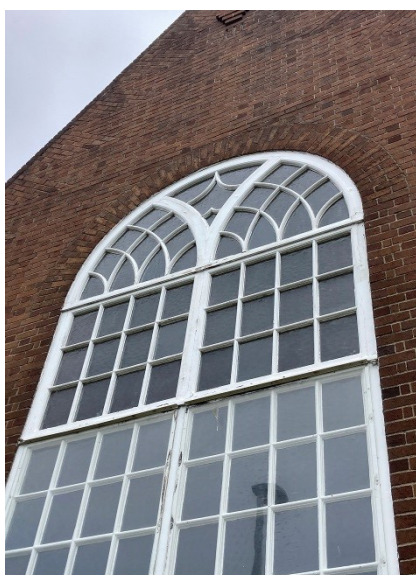
Fig 9  
The west window showing need for redecoration. The partial Perspex secondary glazing detracts from the appearance of the window.

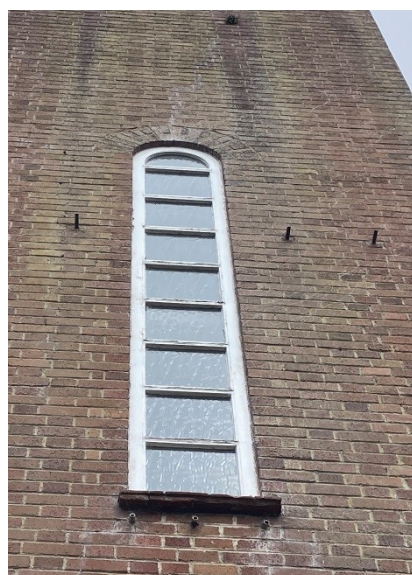
Fig 10  
Tower south window in need of redecoration. Note the weep holes to each side of the window.

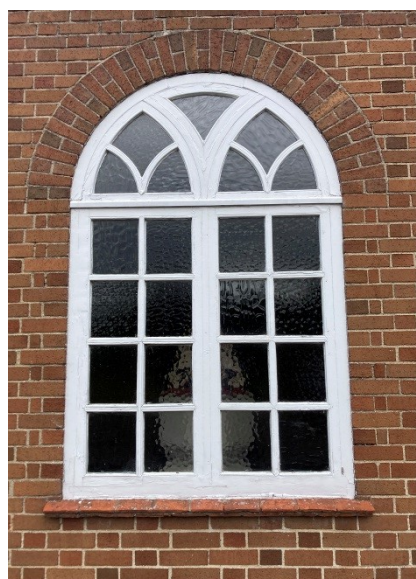
Fig 11  
Further window requiring redecoration.

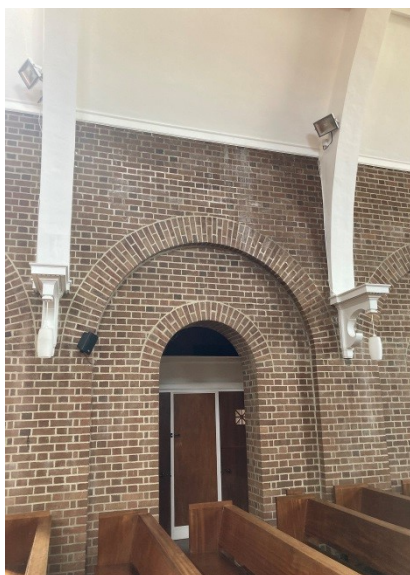
8.8 There is water ingress into the tower, manifesting in two types of defect. There is extensive staining and marking to the ceiling over the confessional and there is also

some surface staining, possibly salts, in the wall of the south aisle arcade and the east fact of the baptistery, where there is also some ceiling damage.

Fig 12  
Damp staining at high level in the  
south arcade below the north wall  
of the tower.

| 25. | Items for Immediate Attention | Ref. | £ |
|---|---|---|---|
| 27.1 | Damp penetration through the tower as manifesting in efflorescence in brickwork and marking on ceilings is a long-standing problem. The 'major works' undertaken in 1993 have not been successful. Well planned research is required and the solution is likely to be complex. | 8.8 – 8.10 | 4 |

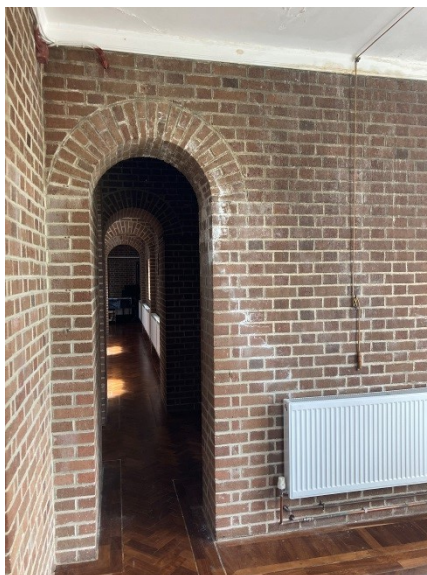
Fig 13  
Ditto below the west wall of the  
tower.

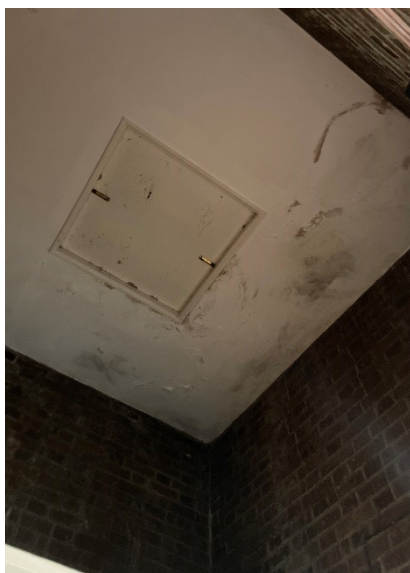
- 12.5 As noted above, the ceiling over the confessional has extensive signs of water ingress which has been so extensive that it is also damaging the joinery of the confessional itself.

Fig 14  
Damp in the ceiling at the base of  
the tower.
