Report on the Quinquennial Survey

WELLINGTON St John the Fisher

Report on the Quinquennial Survey for 2022

Survey by Jonathan Saunders RIBA AABC
12th July 2022
71C St Thomas St, Wells, Somerset, BA5 2UY

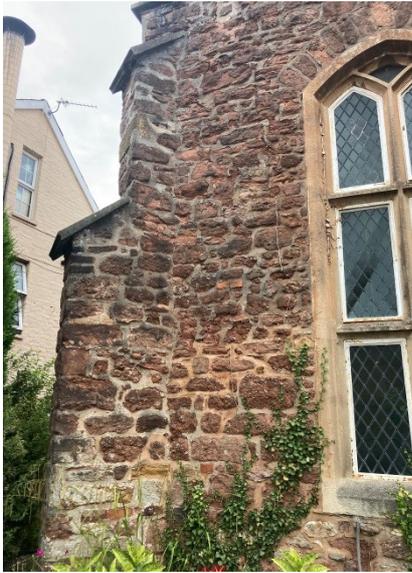
- 8.1 Walls to the C19 building are red sandstone with limestone dressings.
- 8.2 Sandstone has been extensively repointed in cement in multiple stages over the years. This is now causing sacrificial damage to stone, most noticeable adjacent to a window arch (Fig. 2) but in many areas generally, figs 1 & 2.
- 8.3 Repointing of the south wall, including the SE buttress, is recommended within 2 years.
- 8.4 By way of observation, the south wall and east gable of the former presbytery has also been repointed in cement at various stages and, consequentially, is failing at different rates. Repointing here is also desirable. (fig.4)

Fig 1
The south wall and south west buttress showing damage to stone from cement pointing.

| 21. | Items for Immediate Attention | Ref. | £ |
|---|---|---|---|
| 22.3 | Repoint the south wall including the SW buttress. Specification and mortar selection is critical to the success of the work. | 8.3 | 3 |

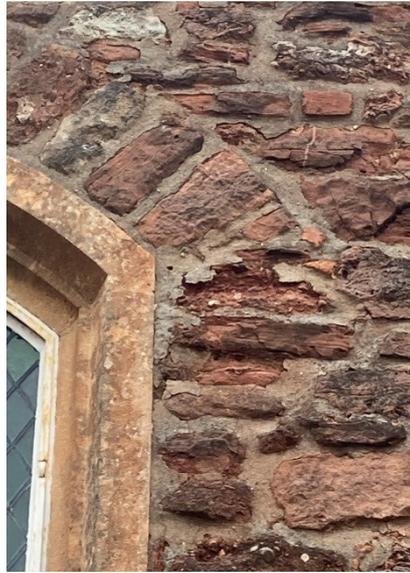
Fig. 2
Detail of the south wall showing preferential damage to stone caused by hard cement mortar.

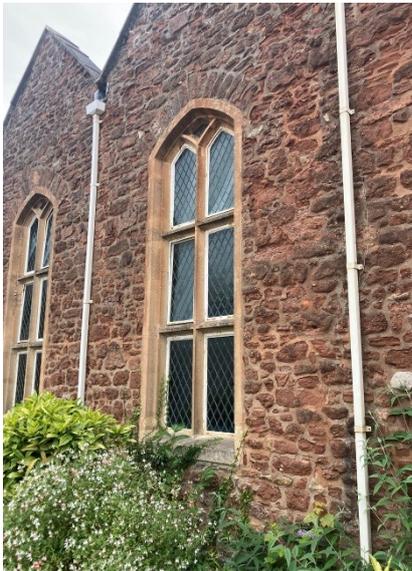
Fig 3
Much of the south wall has cement pointing in various places.

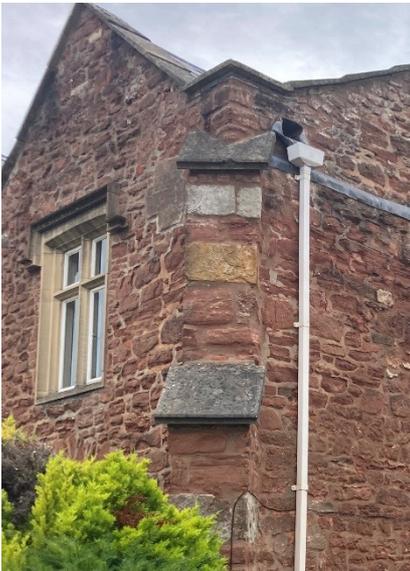
Fig 4
South east buttress of the former presbytery showing walls in generally similar condition to the church.

| 21. | Items for Immediate Attention | Ref. | £ |
|---|---|---|---|
| 22.4 | Although outside the scope of this report, consideration might be given to repointing the south wall and west gable of the former presbytery, which are in similar condition, for consistency. | 8.4 | 3 |

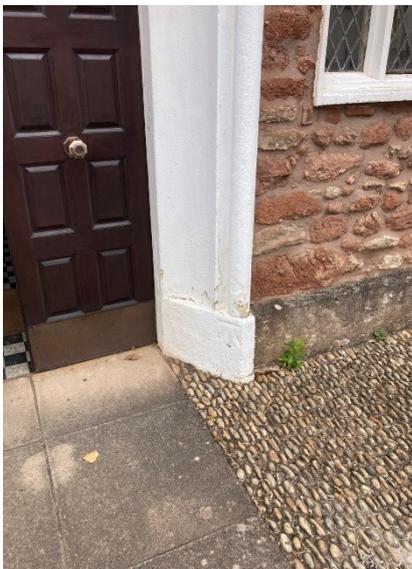
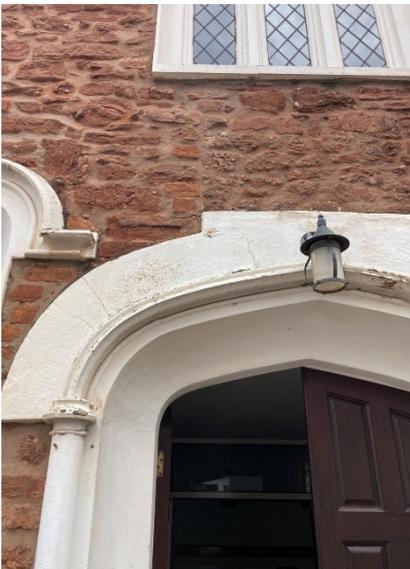
- 8.5 The central bay is also repointed in cement but here it is sound and removal would be unduly destructive.
- 8.6 Door and window surrounds have been painted in gloss paint that is retaining moisture and causing damage to underlying stone, figs. 5&6. As yet this is limited but removal is desirable for long term protection of stone with replacement in a breathable paint.

Figs 5 and 6
Minor damage to stone caused by inappropriate paint.

| 21. | Items for Immediate Attention | Ref. | £ |
|---|---|---|---|
| 22.1 | Redecorate surrounds to doors and windows (but see 24.1 below) | 8.5 | 2a |
| 24.1 | Removal of paint from window surround, notably the entrance bay but ideally all, as modern paint is doing long term damage. | 8.6 | 2b |

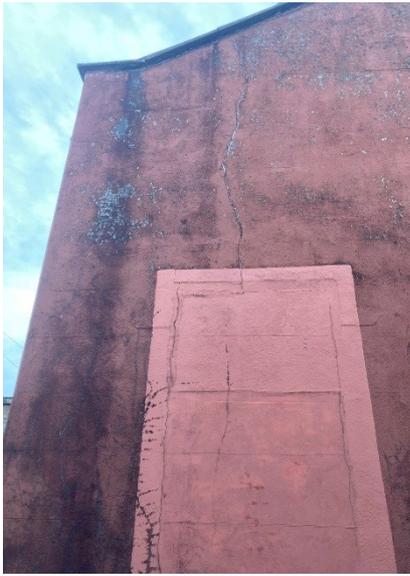
Fig 7

- 8.8 There is a patch near the north end of the west wall, fig. 7, which appears to be building-in of a window. A crack which is structural movement extends nearly to the gable but not evident on the inside which has been dry lined. The cement mortar itself will be doing harm to this elevation and I suspect this was installed, as was the dry lining, because of persistent damp problems.

- 8.9 This approach rarely solves the problem and a much better solution would be to repoint, or possibly render in lime. However, as there is no detrimental effect on the internal decorations because it is dry-lined, this is not an urgent priority.

The built-up window in the west gable, probably in concrete block. There is a structural crack that should be monitored. The cement render will be causing long-term harm to underlying stone and will not be resolving the evident damp problem.

| 21. | Items for Immediate Attention | Ref. | £ |
|---|---|---|---|
| 22.5 | Strip existing and re-render the west gable, incorporating ties across structural cracking. | 8.8, 9 | 3 |

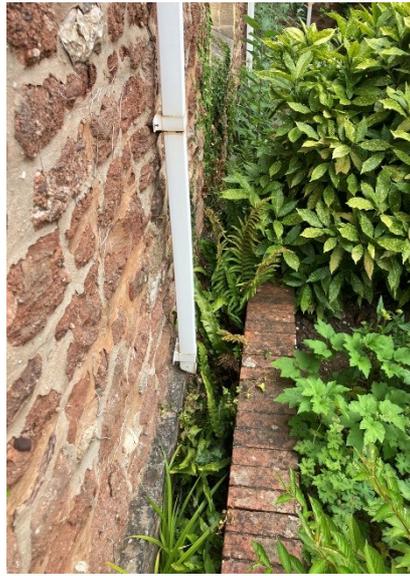
Fig 8

- 9.5 To the south of the church, gutters discharge into a narrow concrete channel, set behind a dwarf brick wall. Fig. 8 In front of the church this channel is being overgrown by ferns and buddleia and, although this is attractive, these are invasive as is the sycamore, which has also self-seeded. This area should be cleared, including the ivy, which is beginning to climb the walls as noted below.

- 9.6 Because this gutter is overgrown I could not see any outlet and this should be investigated and cleaned when plants are removed.
- 9.7 In front of the church room, the new gutters have been configured to connect directly into a hopper and this is a much more positive way of discharging than simply into the concrete channel.
- 9.8 The west end of the church, at the south-west corner, the rainwater pipe discharges into a hopper but I could not see any outlet and I would recommend that this is investigated.
- 9.9 On the north side of the church the rainwater pipes discharge by shoes over gulleys. These all appeared clear at the time of my inspection. I cannot judge, however, how freely the ground sections are running.

Ground gutters to the south wall should be cleared out.

| 21. | Items for Immediate Attention | Ref. | £ |
|---|---|---|---|
| 21.2 | Clean out ground gutters on the south side. Ensure gullies are running free. This issue may be contributing to damp in the base of the wall internally but more considered action may well be required if this is not sufficient. | 9.5, 6 & 8 | 1a |

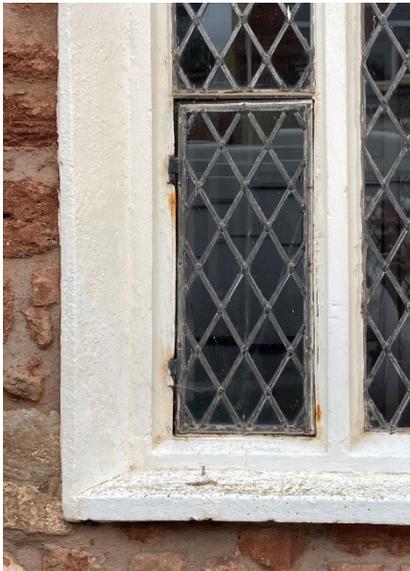
Fig 9

- 10.1 Windows to the church are leaded lights in diamond quarries all within metal frames. Each of the six-light windows has two opening hoppers and these appear to be operating smoothly. The steel surrounds to these leaded lights are showing signs of rust through the paint and redecoration is now required. Consideration might be given to using a darker colour which would be less susceptible to rust grinning through. Fig. 9

Metal casements and outer frames of windows require overhaul and redecoration.

| 21. | Items for Immediate Attention | Ref. | £ |
|---|---|---|---|
| 22.6 | Redecorate window ironwork | 10.1 | 2b |

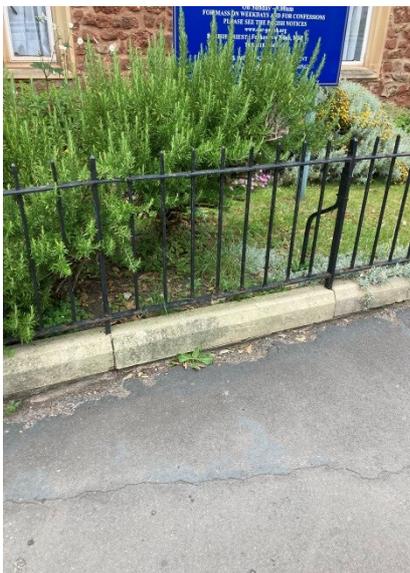
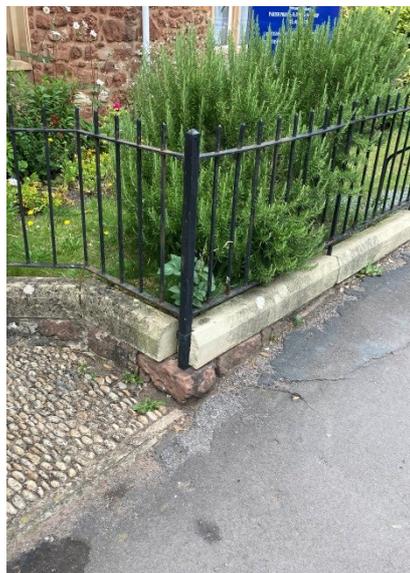
Figs 10 and 11

11.2 These areas are enclosed by low metal railings of no great age, sitting on a low wall with stone copings over rubble. There is some damage from rusting, particularly the corner post, where the end of the coping has fallen away on both sides of the entrance. Fig 10 & 11. Decoration is desirable.

11.3 Railings themselves are in need of thorough preparation and redecoration.

11.4 There is some further displacement of copings immediately to the east of the entrance caused by rust. These deserve repointing but I don't resetting is justified at the present.

Railings to the front elevation require redecoration and repair to copings.

| 21. | Items for Immediate Attention | Ref. | £ |
|---|---|---|---|
| 23.2 | Redecorate churchyard railings | 11.3 | 1b |
| 23.3 | Repair copings to boundary railings | 11.4 | 1b |
