TAUNTON St George Parish Centre

Report on the Quinquennial Survey

2022
Report by Jonathan Saunders RIBA AABC
Date of Inspection 28 June 2022

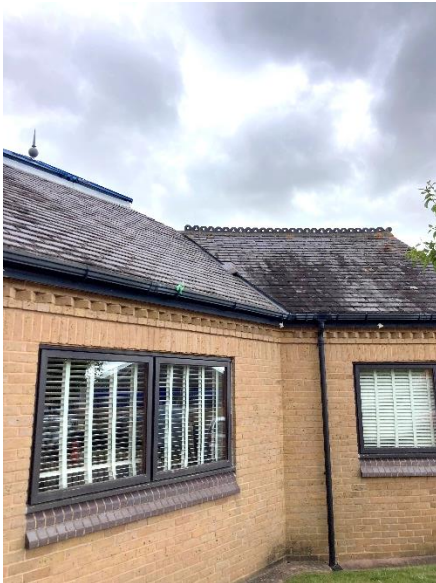
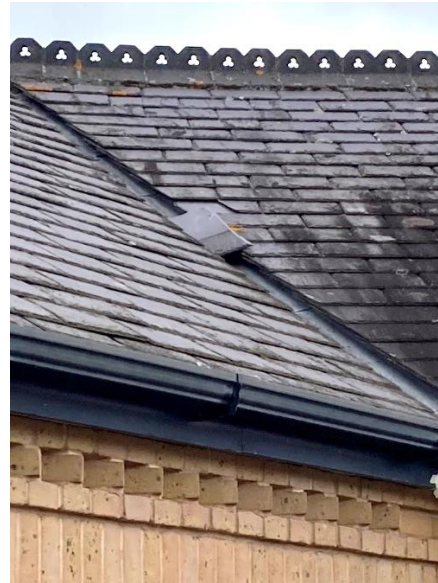
7.2

There is single slipped slate above a valley on the west side of the roofs. This is unlikely to be admitting water but should be refixed as soon as practical.

8.1	Items for Immediate Attention	£
8.1.1	Replace the slipped slate above the valley on the west side of the roof.	1a
8.1.2	Inspect rainwater goods occasionally during heavy rain for signs of blockage.	Nil
8.1.3	Review staining of the meeting room wall periodically for signs of deterioration	Nil
8.2	Items for Attention within Two Years	
8.2.1	Kill ivy and any other pernicious plants on the north boundary wall. The ivy in particular may require multiple applications.	1a
8.2.2	Repoint open joints in the north boundary wall	1b
8.3	Items for Attention within the Quinquennium	
8.3.1	None

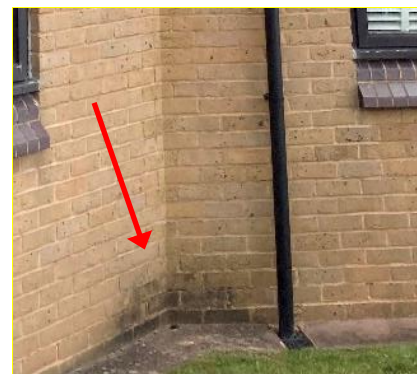
- 7.3 External brickwork, including cills to windows, is good overall condition with little to report.
- 7.4 Doors and windows are stained timber double glazed of apparently good quality and all in good order.
- 7.5 Rainwater goods are all plastic. They appear well fixed with no indication of leaking joints in gutters. but
- 7.6 I did note some slight marking in the wall below the valley gutter with the slipped slate which might indicate that the gutter is over-brimming.

Vegetation around rainwater goods could indicate overflowing

7.8 I recommend that all rainwater goods are inspected occasionally during heavy rain for signs of blockage.

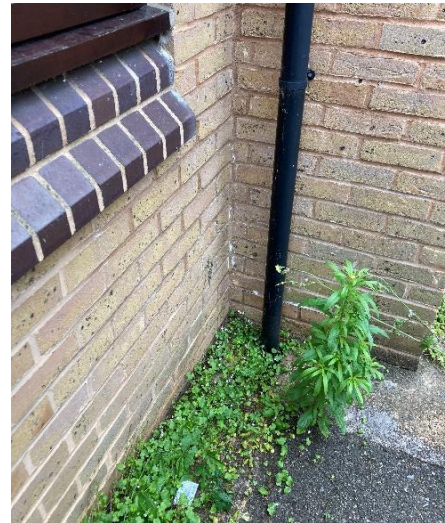
I suspect that the relatively limited vegetation is benign rather than a result of saturated ground from blocked drains but this should be monitored.

Vegetation around rainwater goods could indicate overflowing as above

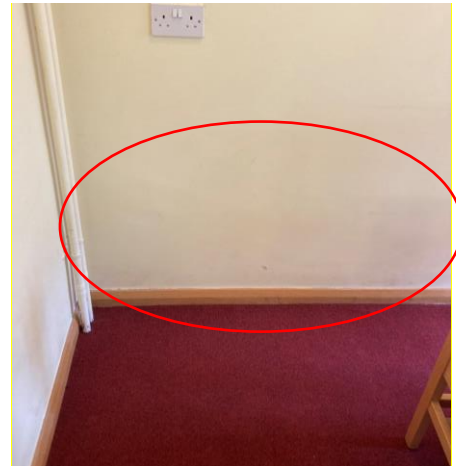
7.10 There is very slight staining, only just perceptible, to the wall of the meeting room behind the kitchen.

This wall is in the centre of the building and although there is a theoretical risk of failure in the DPM as installed I consider this extremely improbable and the marking does not in any case have characteristic 'tide mark' of salt damage which is very difficult to completely conceal in redecoration.

There is no recollection of any pre-existing defect in the basin waste that might have caused the damp but I nevertheless, believe this is the most likely cause of the issue and recommend that

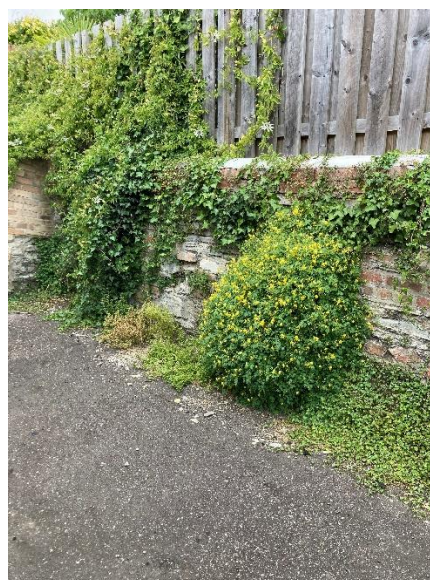
The stone work is supporting quite extensive vegetation, some of which such as ivy, can be invasive.

This growth indicates failed pointing which can be seen in some areas but which is likely to be worse behind growth.
